Manhole Inspection Summary

Manhole # S29K__050MH

Insp Date: **2/2/09 11:41 AM**

Location Address: **Washington Blvd.**

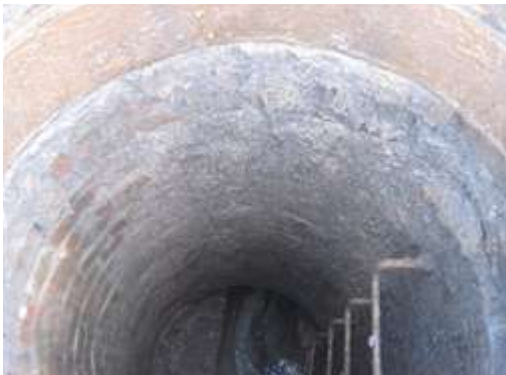
Defect 2

Infiltration: ☐ None ☐ Joint ☐ Cracks ☒ Mortar ☐ Roots ☒ Wall

Infiltration: ☐ None ☐ Joint ☐ Cracks ☐ Mortar ☐ Roots ☒ Wall

chimney infiltration from mortar & wall;
corbel infiltration at wall

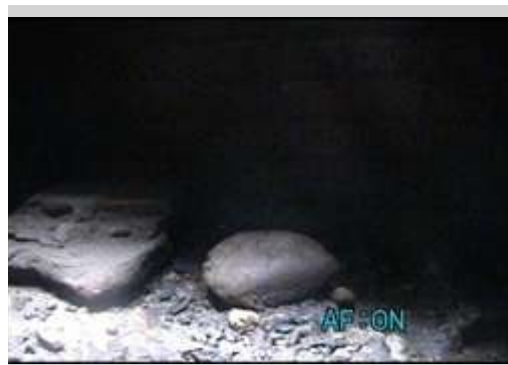
Defect 1

Condition: ☐ Sound ☐ Cracked ☐ Root Intrusion ☐ Deteriorated ☐ Leaks ☒ Debris

bench debris

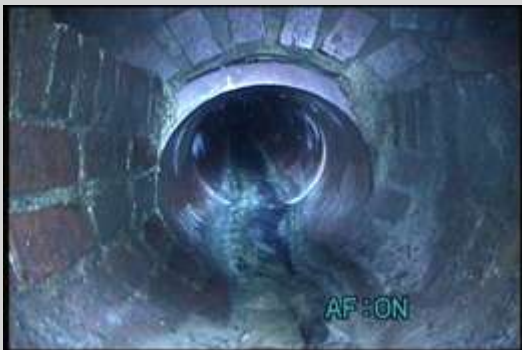
12 O'Clock Outflow

15 in. Circular Gravity Sewer
Pipe Out @ 12 O'Clock

Invert Depth: 9.82 (ft.) Flow Characteristics: **Slow**

Infiltration: **None** Pipe Seal Cond: **Sound**

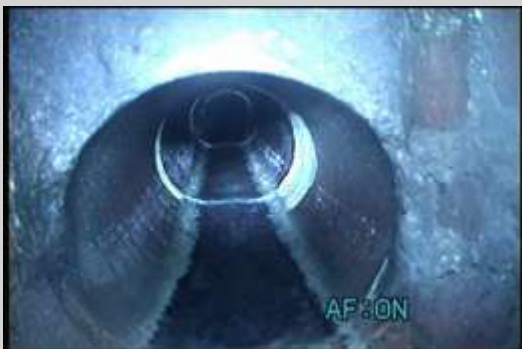
3 O'Clock Inflow

8 in. Circular Gravity Sewer
Pipe In @ 3 O'Clock

Invert Depth: 10.20 (ft.) Flow Characteristics: **Slow**

Infiltration: **None** Pipe Seal Cond: **Sound**

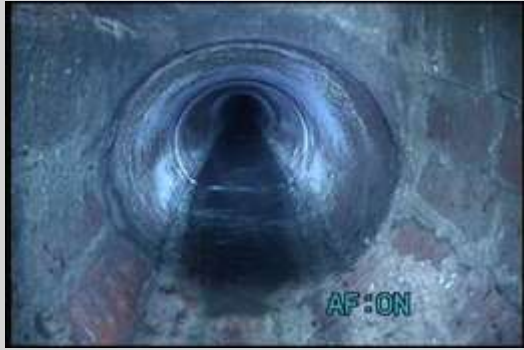
6 O'Clock Inflow

12 in. Circular Gravity Sewer
Pipe In @ 6 O'Clock

Invert Depth: **10.18** (ft.) Flow Characteristics: **Slow**

Infiltration: **None** Pipe Seal Cond: **Sound**
